Manhole Inspection Summary

Manhole # S03UU1017MH

Insp Date: **9/25/06 9:06 AM**

Location Address: **3506 TRAINOR AVE**

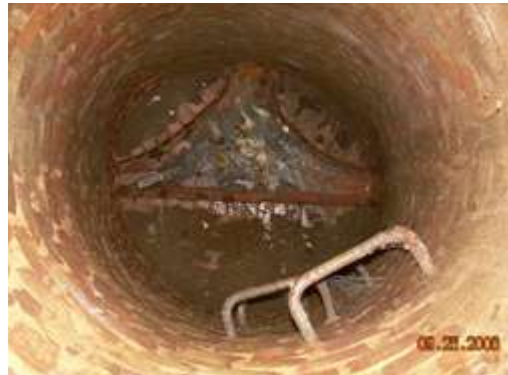
Top View

Adjustment and Barrel infiltration.
Corroded steps. Evidence of surcharge -
Bench debris. Channel debris.

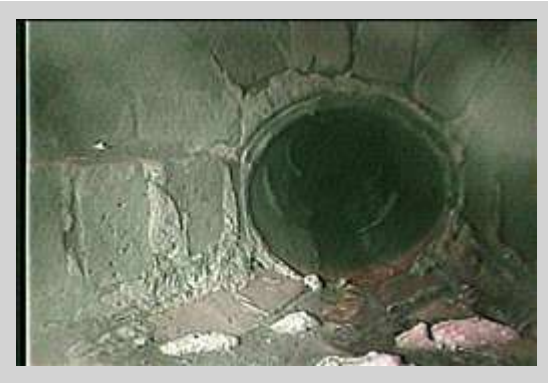
8 in. Circular Gravity Sewer Pipe Out @ 12 O'Clock

Channel deterioration.

Infiltration: **Evidence** Pipe Seal Cond: **Unknown**

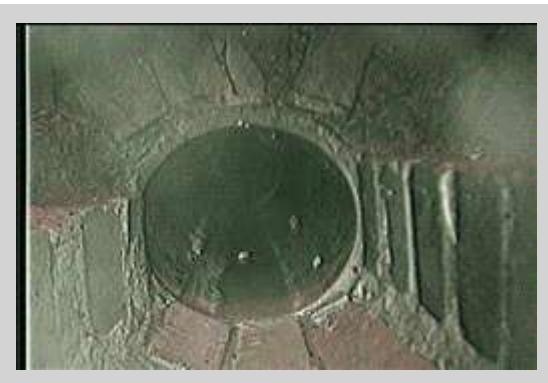
8 in. Circular Gravity Sewer Pipe In @ 3 O'Clock

Infiltration: **Evidence** Pipe Seal Cond: **Cracked**

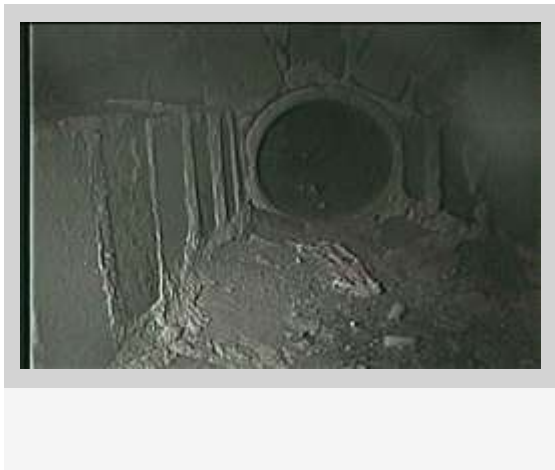
6 in. Circular Gravity Sewer
Pipe In @ 9 O'Clock

Comments **The I9 pipe seal is not flush to the pipe.**
